Docket No. SA-537

Exhibit No. 6-W

Boeing Presentation Airplane Cabin Crashworthiness & Occupant Protection

# NTSB Investigative Hearing 777 Landing Accident at San Francisco Panel 5 – Airplane Cabin Crashworthiness & Occupant Protection

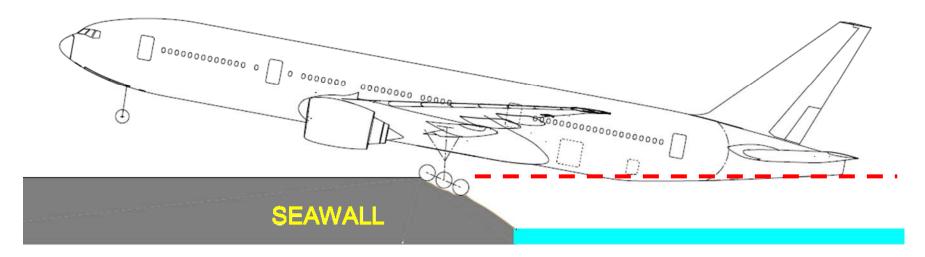
- The main landing gear and aft fuselage impacted the seawall at over 100 kts, resulting in severe longitudinal impact loads.
  - The main landing gear separated from the wings.
  - The aft fuselage structure was heavily damaged, resulting in separation
    of the tail and the release of the aft galleys and cargo onto the runway.
- The airplane continued down the runway resting on the nose landing gear and the engines.

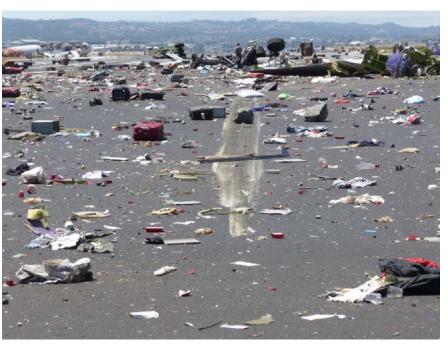
- The left engine separated.
- The airplane rotated 330 degrees counter-clockwise, pivoting about the nose wheel while sharply inclined to the ground.
- The fuselage was subjected to severe vertical and side loads at the end of the rotation when the fuselage impacted the ground.
- The right engine separated.
- As the airplane slid to the final position, the fuselage sustained additional severe side loads that peeled open the lower aft fuselage.
- Fire ignited at right engine oil tank, outside the fuselage. Video showed black smoke coming from Door 1L approximately 15 minutes after the airplane came to rest. Smoke or fire did not prevent complete evacuation of the airplane.

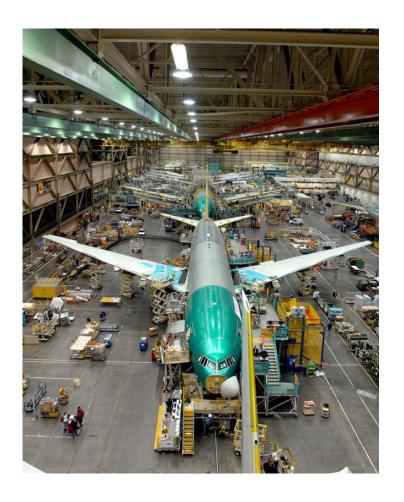
# **Safety Design Goals**

- Three safety design goals:
  - Survive an impact
  - Survive a fire
  - Evacuate the airplane
- The airplane performed extremely well with respect to each goal despite being subjected to severe longitudinal, vertical, and side loading.

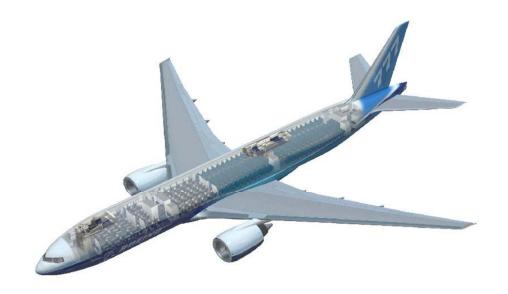
- Boeing 777 fire protection features are designed to resist fire, allowing time for passenger evacuation.
  - Engines and main landing gear are designed to separate to prevent fuel tank rupture.
  - Insulation blankets and cabin materials resist fire propagation.

Fire protection features allowed time for passenger evacuation

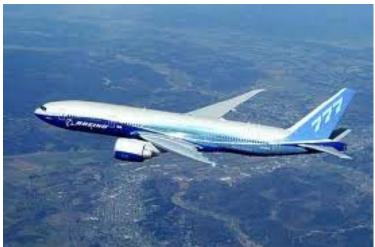
- The Boeing 777 is designed and tested to enable evacuation of all passengers and crew within 90 seconds, as required by FAA regulations.
  - Test done with half of exits blocked, under night lighting conditions.
- Features that expedite evacuation:
  - Simple operation exits and doors;
  - Seats and other interior features stay secure, keeping aisles free; and
  - Automatic, self-inflating escape slides.
- Despite the structural damage from the multiple severe impacts, doors opened, seats and interior monuments stayed clear of the aisles, and passengers were evacuated from the airplane.

**Evacuation system enabled a timely evacuation**
